Republika e Kosovës  
Republika Kosovo - Republic of Kosovo

Autoriteti i Aviacionit Civil i Kosovës  
Autoritet Civilnog Vazduhoplovstva Kosova  
Civil Aviation Authority of Kosovo

# Occurrence Reporting Overview 2025

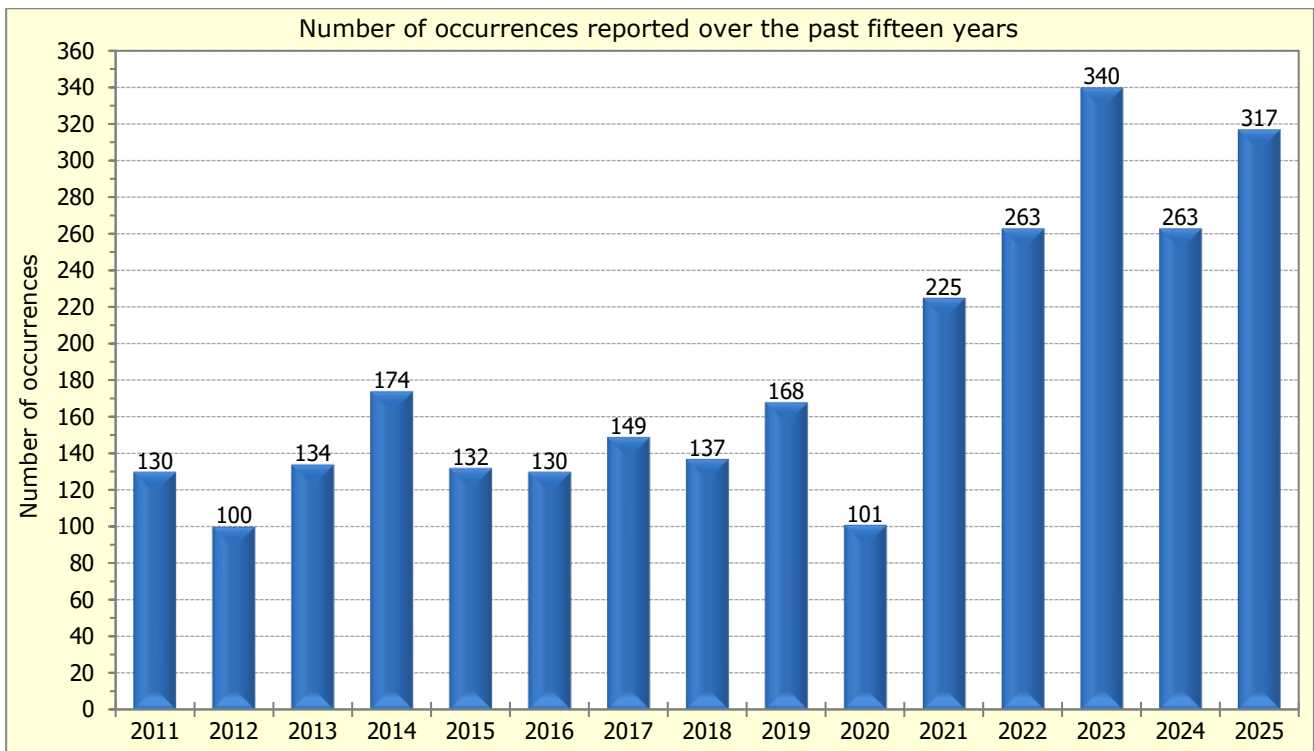
**Figure 1.** Number of occurrences reported over the years: 2011- 2025

The number of **317 occurrences** reported in 2025 is higher by **142.3 occurrences** or **81.5%** than the average of 174.7 occurrences in the previous 14 years, 2011 - 2024. While the total number of occurrences reported to the CAA, from 2006 (when the occurrence reporting system was established in Kosovo) until the end of 2025, reached a total of **3027 occurrences**.

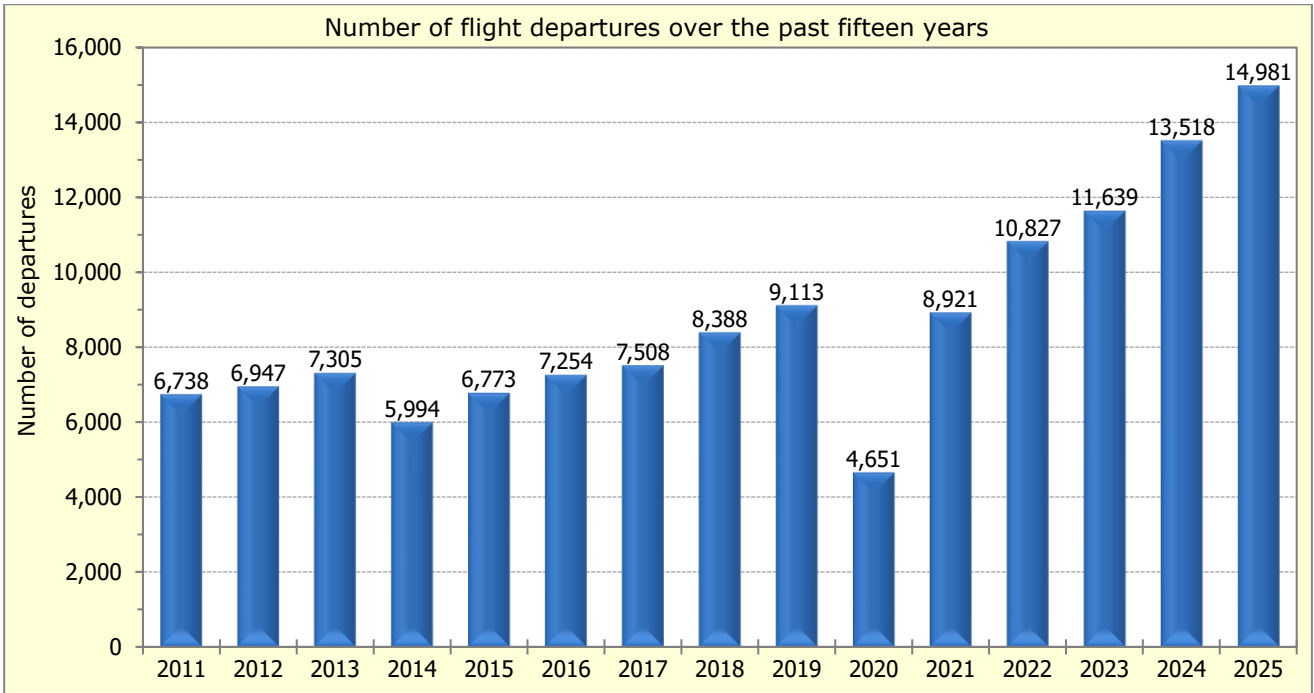
**Figure 2.** Number of flight departures over the years: 2011 - 2025

- 2025 Rate: **21.16 occurrences per 1,000 departures** (317/14,981).
- 2024 Rate: **19.45 occurrences per 1,000 departures** (263/13,518).
- Historical Context: While the rate has increased slightly from 2024, it remains significantly lower than the peak reporting year of 2023 (29.21 per 1,000). This suggests that while the volume

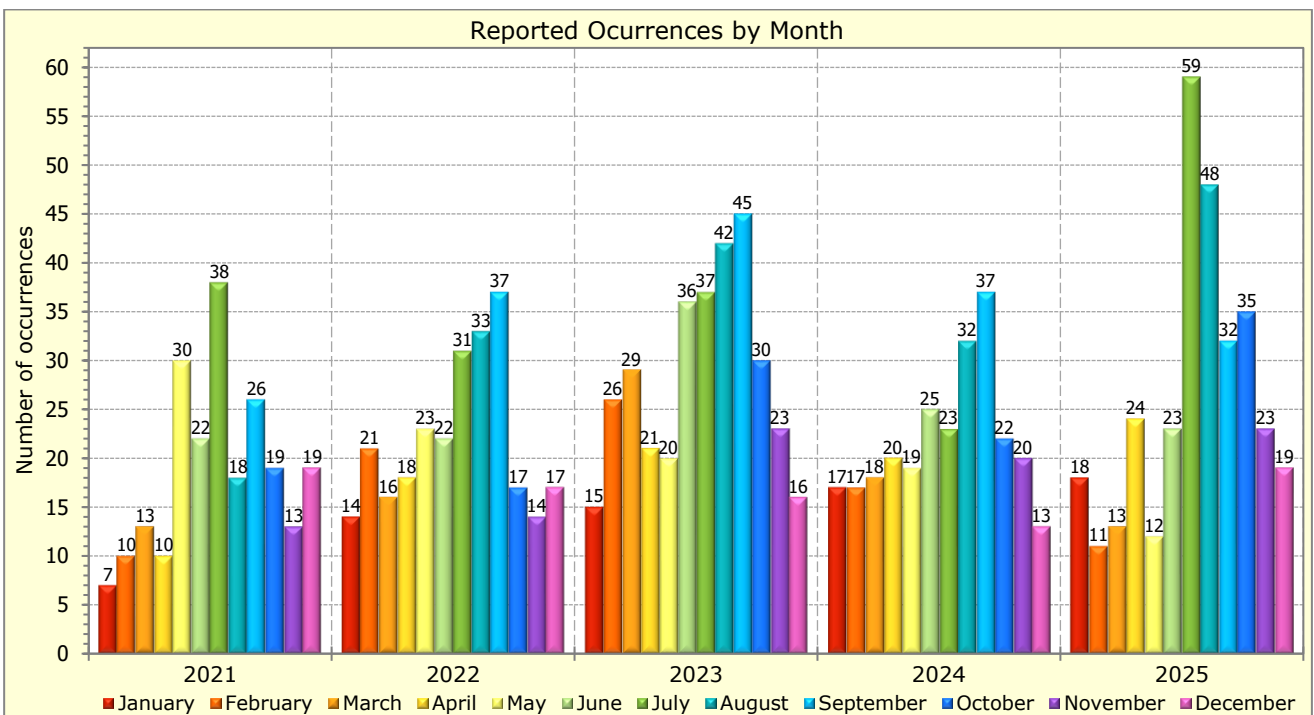
**Figure 3.** Occurrences that occurred per month during the years: 2021-2025 and that were received by the CAA

- The “Summer Stress” Test: July and August represented the peak of operational complexity. July saw a massive spike to **59 occurrences**, driven by the convergence of high traffic volume, peak bird activity, and a localized cluster of Laser Attacks (9 in July).

- Winter Resilience: Despite winter operations usually bringing de-icing risks, January and December remained statistically average (18 and 19 occurrences), indicating effective winter ops management.

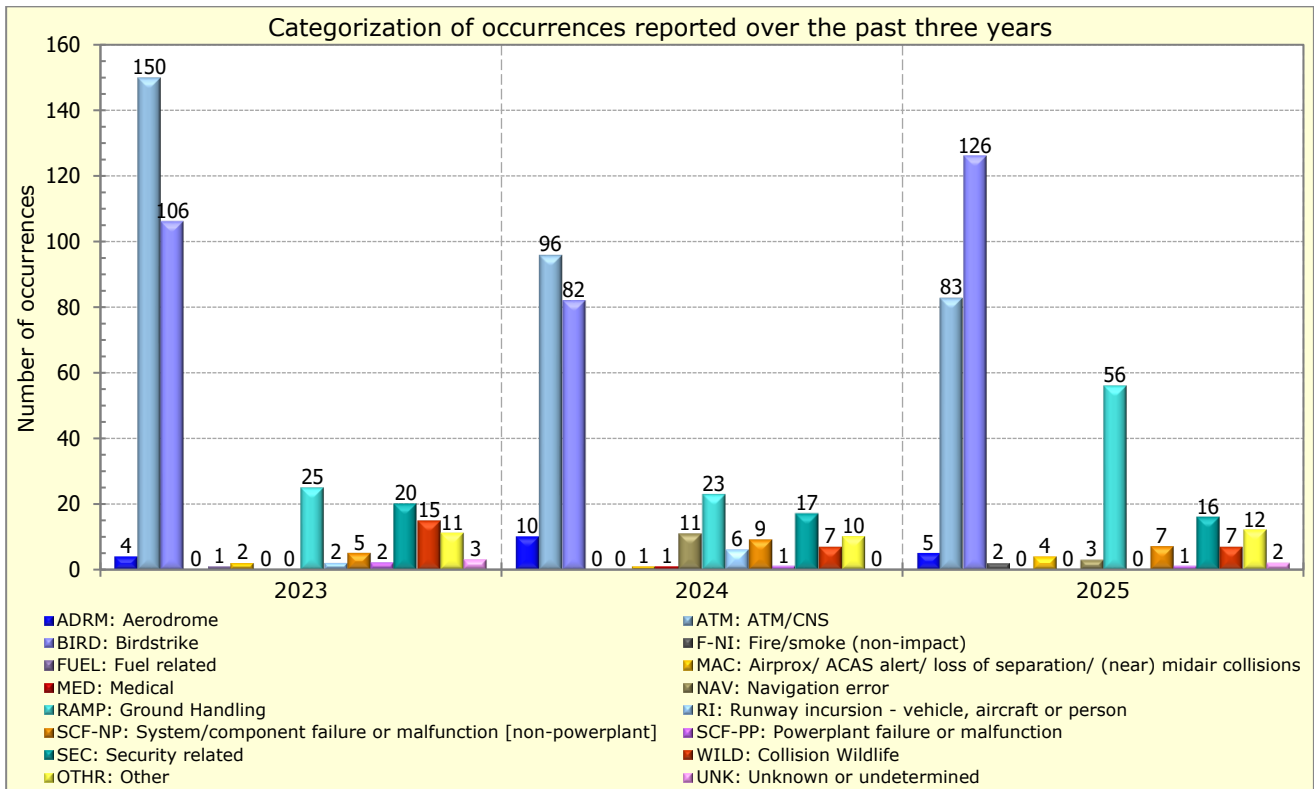
**Figure 4.** Categorization of occurrences reported over the years 2023, 2024 and 2025

- Trend: The BIRD category is the single largest driver of the 2025 occurrence increase. Reports rose from **82** (in 2024) to **126** (in 2025), a **53.6% increase**.
- Rate Increase: The rate of birdstrikes rose to **84.1 per 10,000 departures**, up from 60.6 in 2024. This indicates that the risk of striking a bird increased disproportionately to the increase in flights.
- Seasonality: The risk profile is heavily weighted to late summer/autumn, with **August (29)** and **October (24)** accounting for 41% of the year’s total strikes.

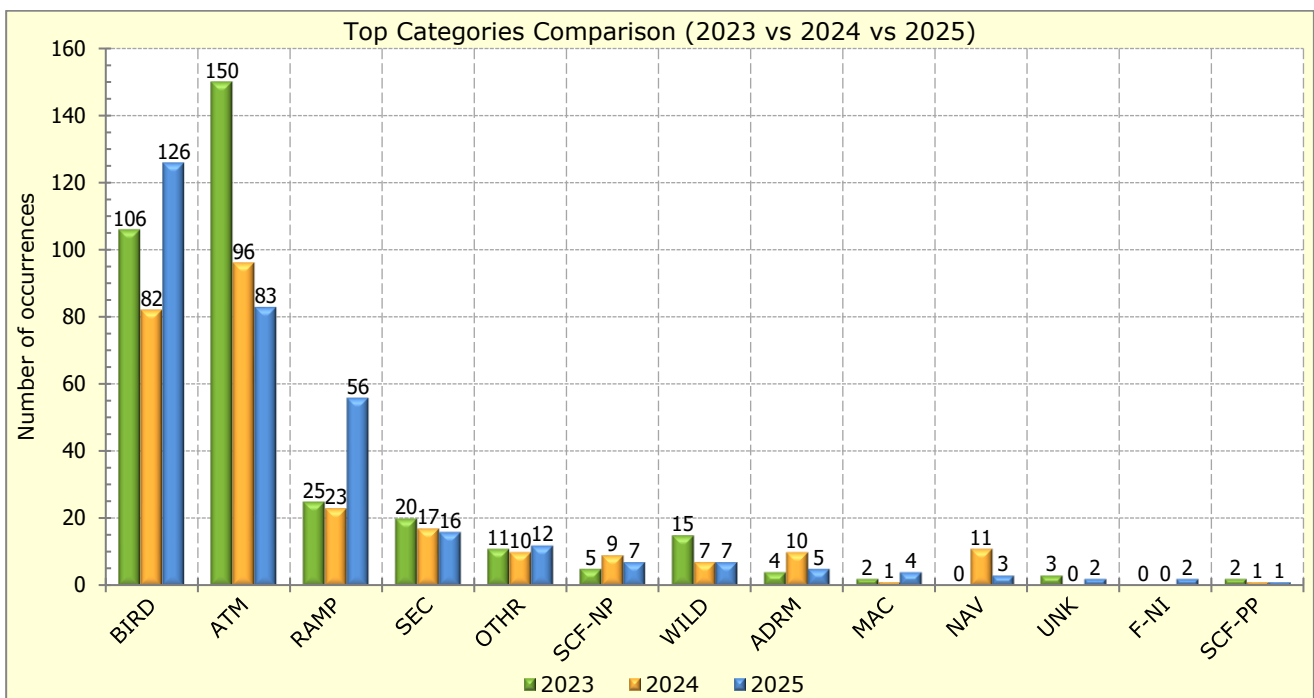
**Figure 5.** Comparison of top categories for the years 2023, 2024 and 2025

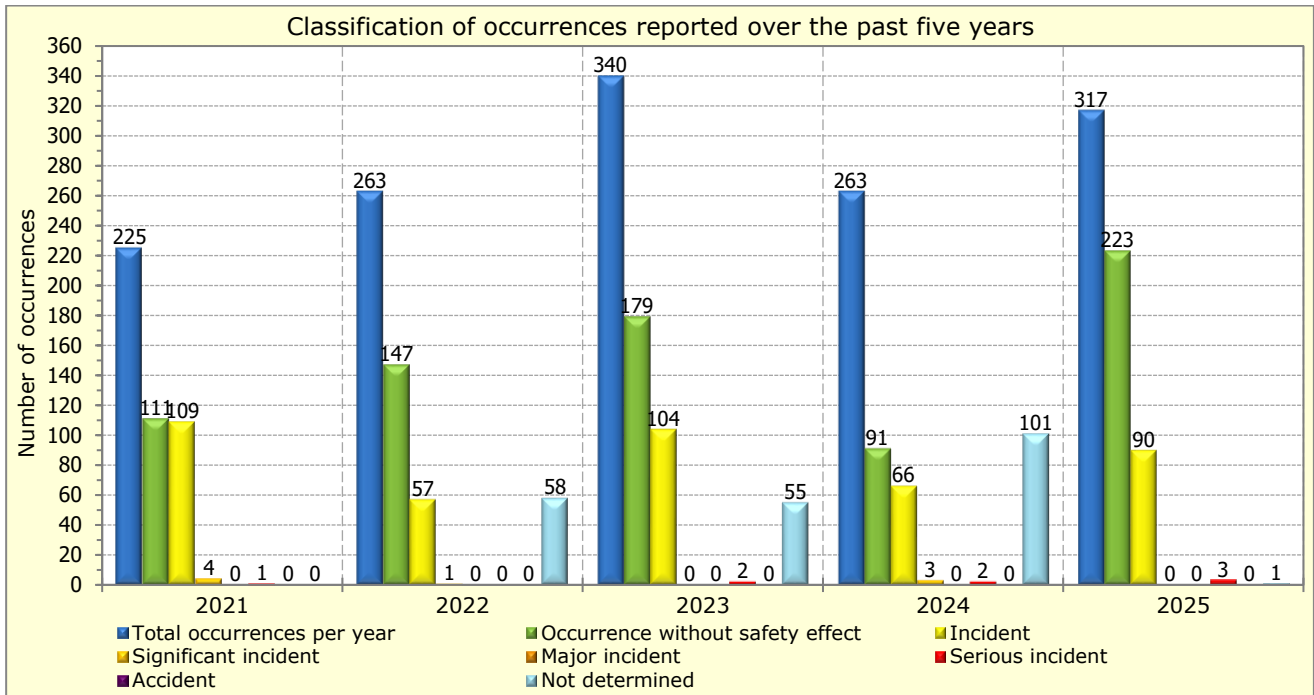
**Figure 6.** Classification of occurrences reported over the past years: 2021 - 2025

- **Occurrences without safety effect (OWSE):** 223 (70.4%).
- **Incidents:** 90 (28.4%).
- **Serious Incidents:** 3 (0.9%).
- **Not determined:** 1 (0.3%).

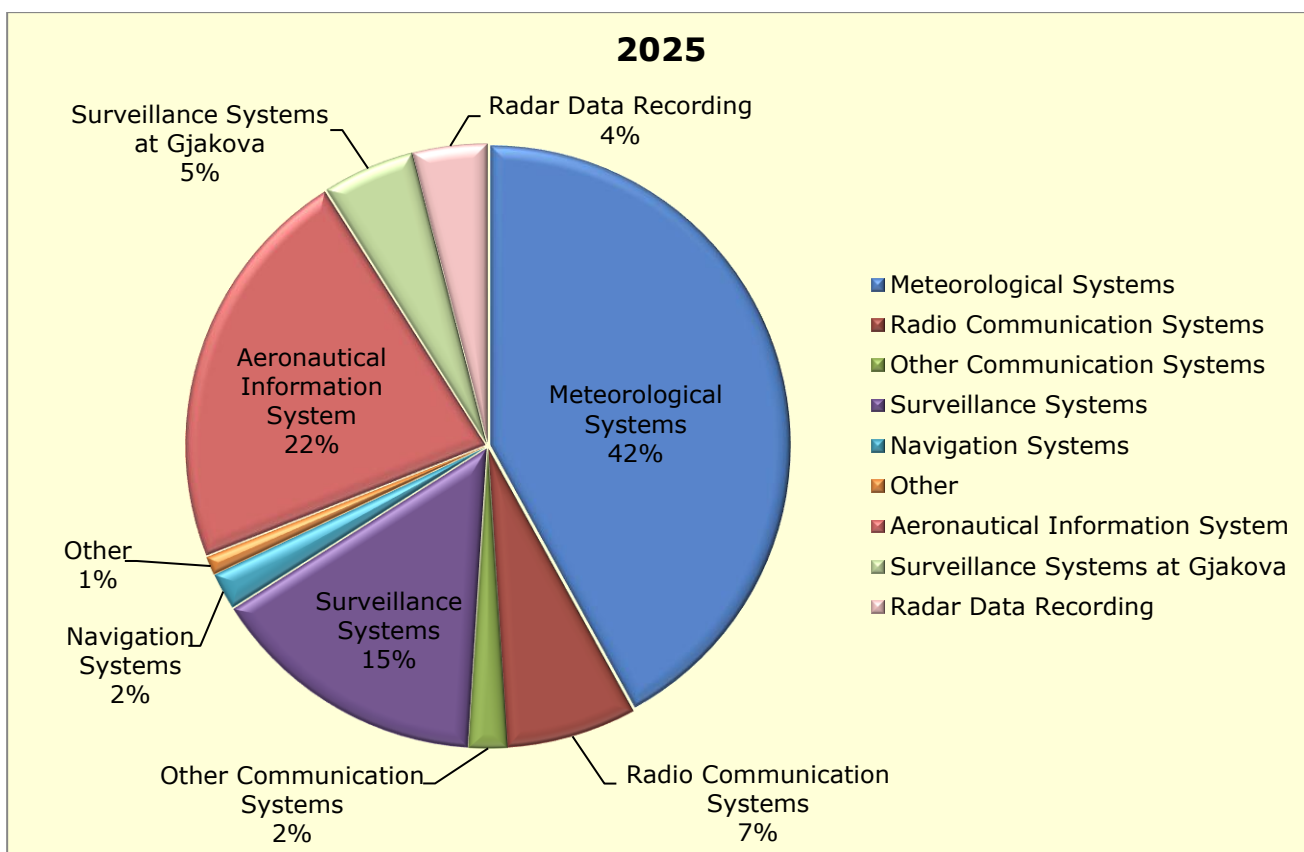
**Figure 7.** A breakdown of the ATM occurrences into sub-categories

The table below and Figure 7 shows that during 2025, occurrences concerning ATM systems and procedures (including Aeronautical Information and Meteorological Services) accounted 26% of all occurrences reported during the year. This percentage does not indicate that safety was compromised, as backup systems are in place for these services. Rather, it reflects the positive reporting culture demonstrated by ANSP personnel.

From the table above and the Figure 7, occurrences involving meteorological equipment, aeronautical information systems and surveillance systems were the most prominent during 2025, accounting for 42%, 22% and 15%, of the overall ATM occurrences, respectively.

Of the 22% of occurrences related to aeronautical information systems, 4% were associated with system failures of CRONOS, while 18% involved human errors related to data entry by staff.

Out of the total 15% of occurrences related to the surveillance systems, 3 % were related to the resets of Controller Working Position (CWP) or radar data loss, while 12% were related to radar data processing problems.

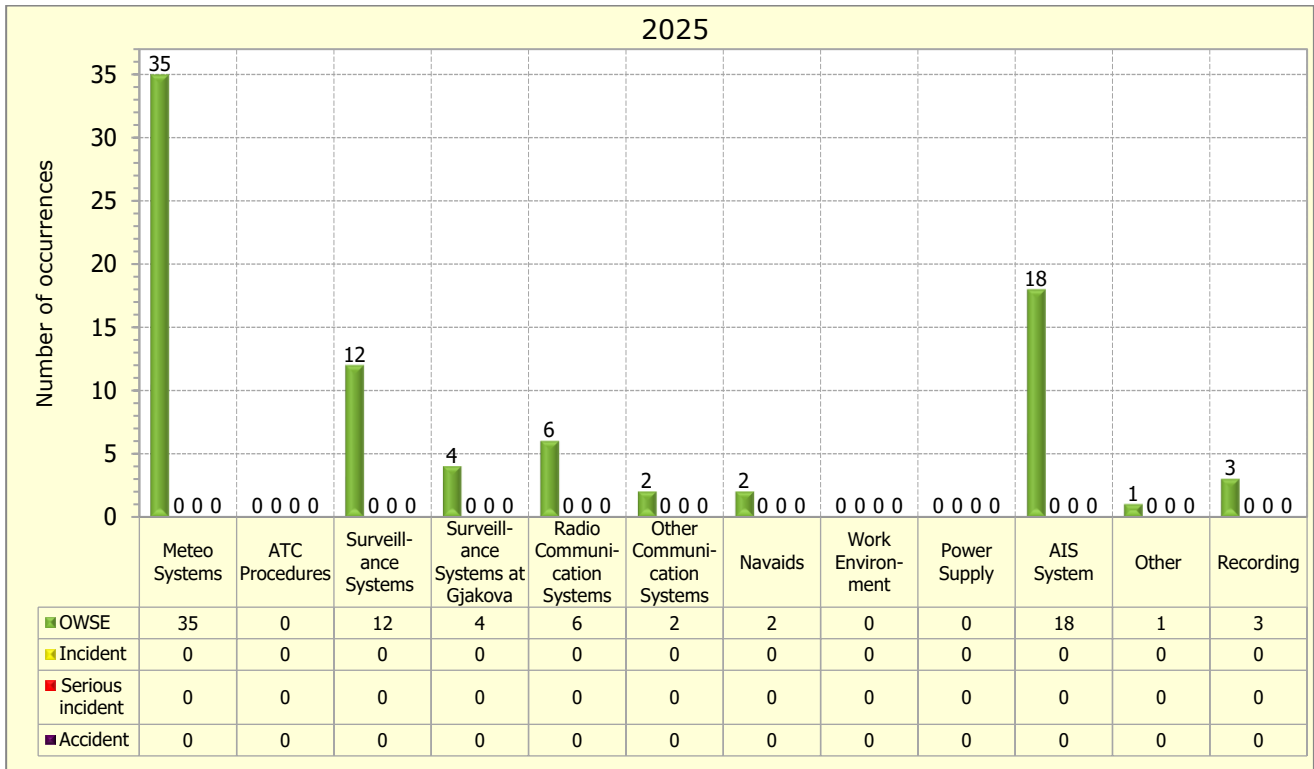
**Figure 8.** ATM occurrences according to their severity classification

Furthermore, the Figure 8 shows graphically sub-categories of the ATM related occurrences according to their severity classification.

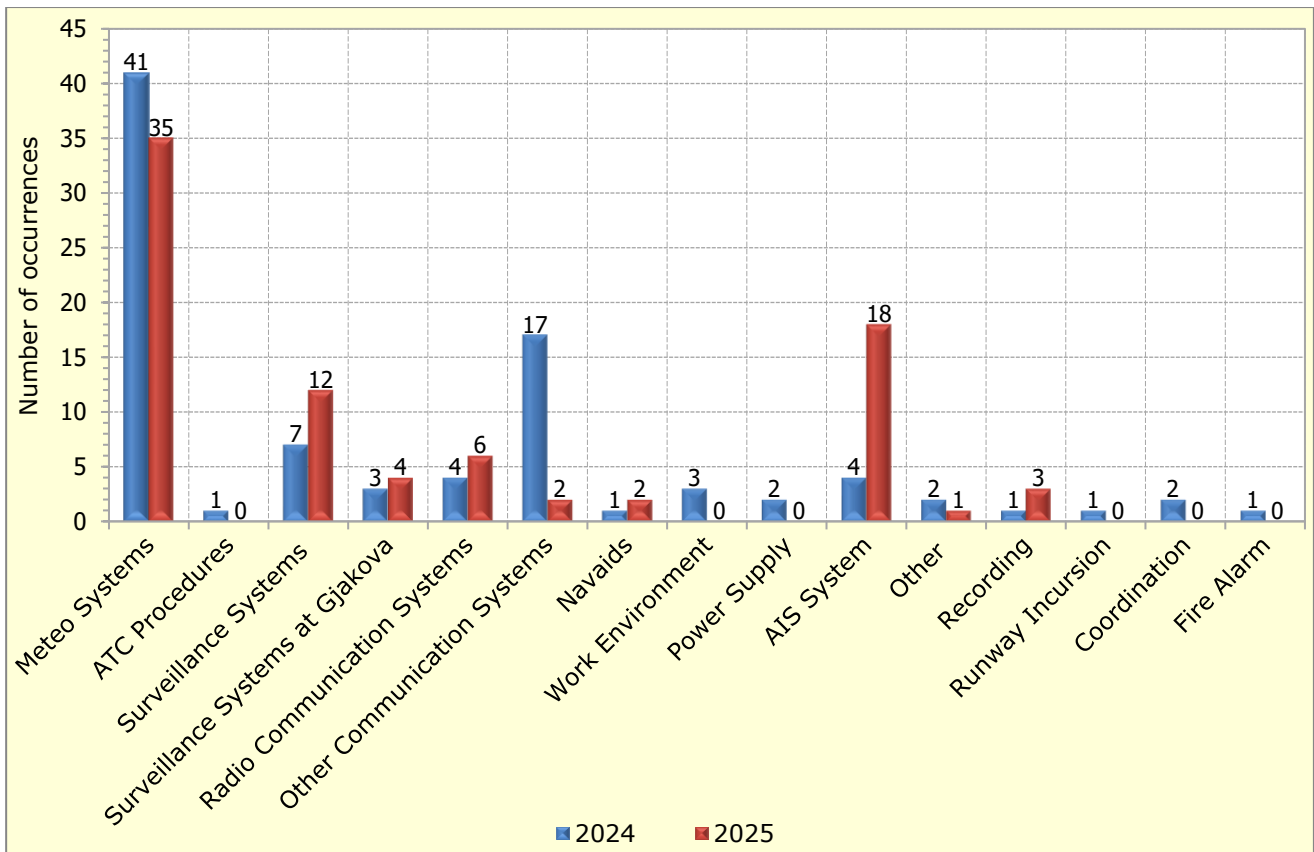
**Figure 9.** A comparison of the ATM occurrences reported during 2024 and 2025

Whereas, Figure 9 below shows the breakdown of the ATM related occurrences, reported during the past two years, into specific sub-categories and the number of occurrences within these sub categories.

If we compare the categories between 2024 and 2025, it is observed that some of them have shown an increase, while others have experienced a slight decrease. A decrease was noted in meteorological systems (from 41 to 35) and other communication systems (from 17 to 2). However, an increase was noted in aeronautical information services, from 4 occurrences in 2024 to 18 in 2025.

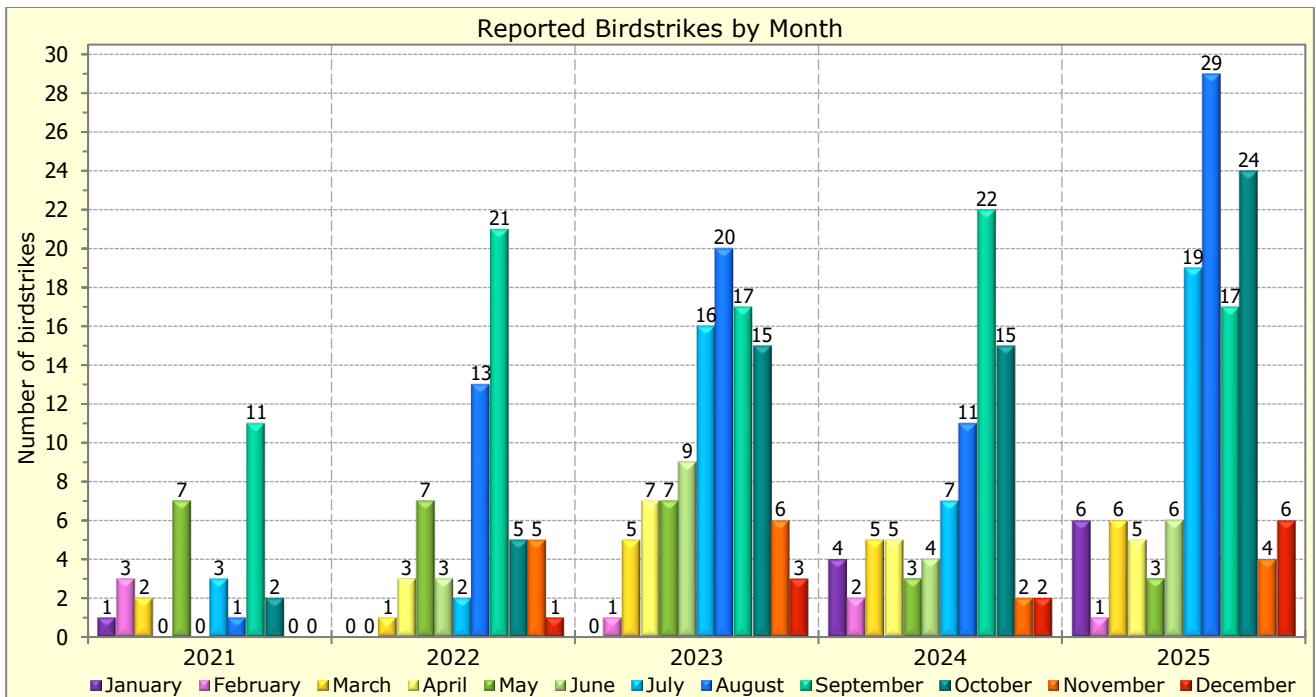
Figure 10. Birdstrikes reported during 2025 compared to the previous four years

Figure 10 below shows the trend of the reported birdstrikes per each month during 2025.

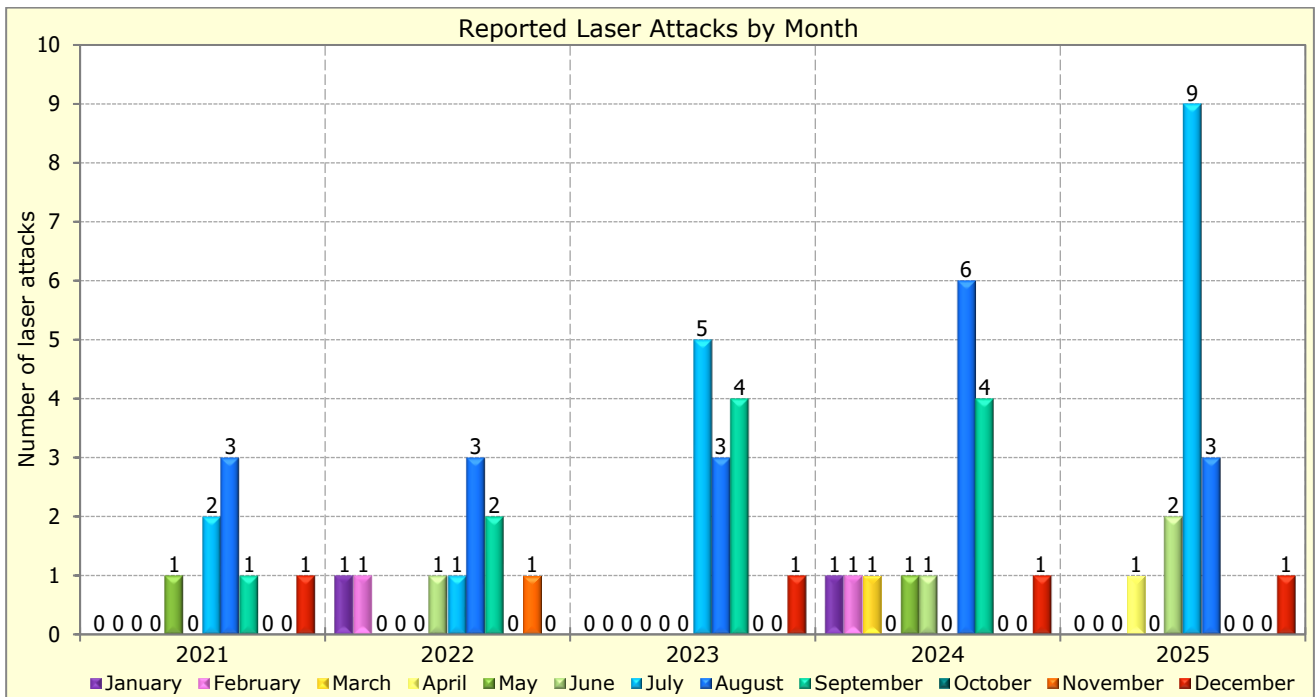
**Figure 11.** Laser attacks reported during 2021 - 2025

Figure 11 above presents a comparison of the reported laser attacks by month over the past five years: 2021 - 2025.

As stated in the Statistical Data Analysis section of the Overview and as can be seen in the figure above, after a big decline in 2020, influenced by the COVID-19 pandemic, with only 2 occurrences, the SEC category (which contains the Laser attack sub-category) has been gradually increasing since 2021, when it had 8 occurrences, to a new high of 16 occurrences recorded in the last two years, 2024 and 2025. A relatively high number of laser attacks can be a worrying sign as they can lead to pilot incapacitation and have serious consequences for the safety of aircraft operations.

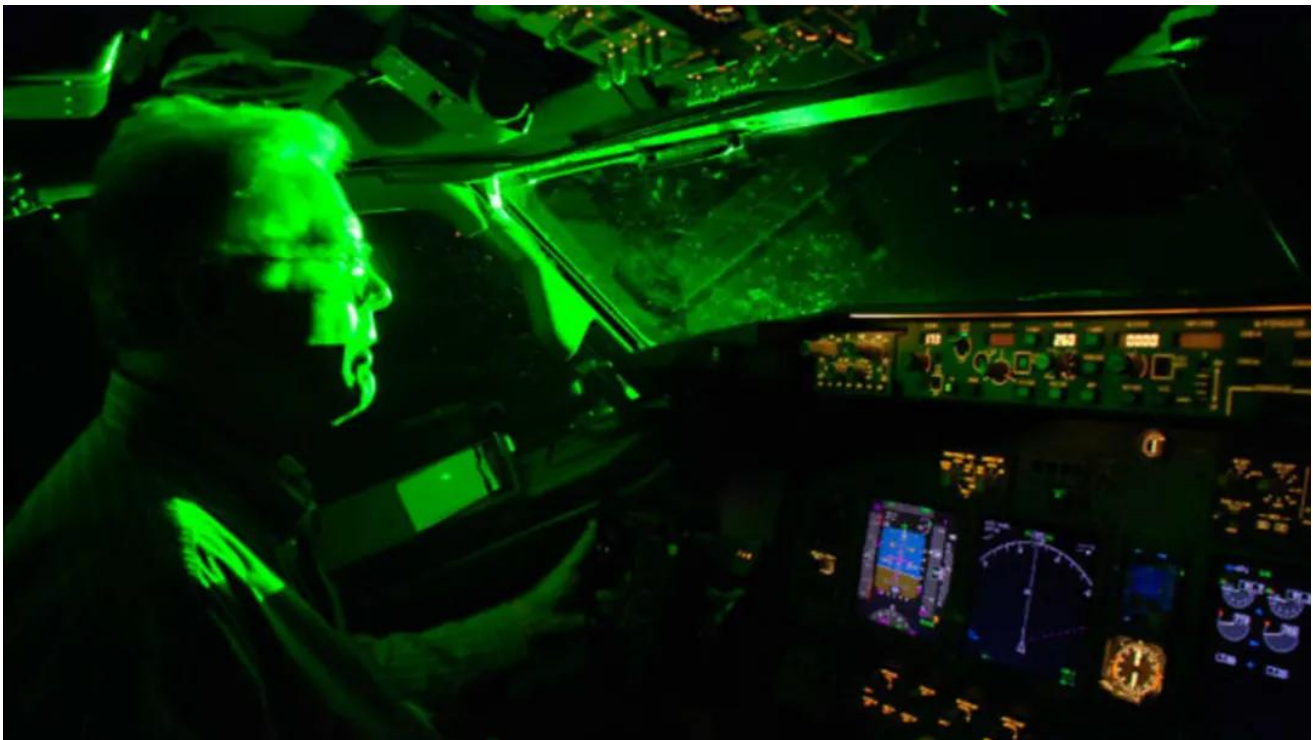
**Image 1.** Illustration of the visual effects of a laser pointed in a cockpit (Courtesy of: FAA)
